## CONSERVATION MANAGEMENT PLAN

## ANGLICAN CHURCH OF ST JOHN THE BAPTIST CANBERRA, ACT - SIGNIFICANT STRUCTURES

Prepared by Philip Leeson Architects Pty. Ltd.

Issue: Final - Approved by ACT Heritage Council 10.11.15.

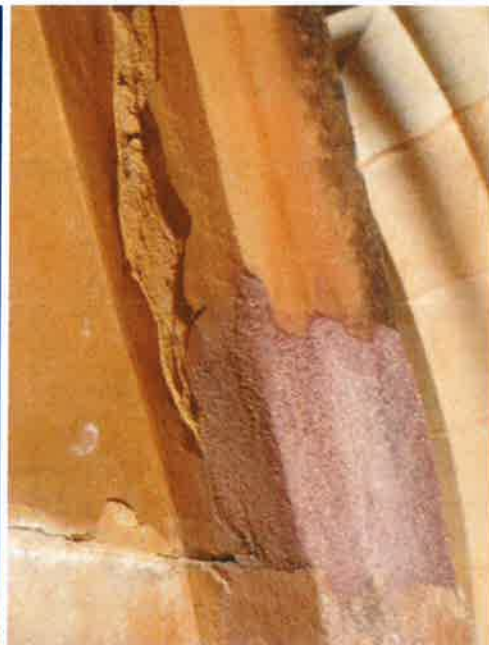
Photo 13: Dolpin lantern over West Entry, 1956 Photo 14: Stone deterioration at West Porch

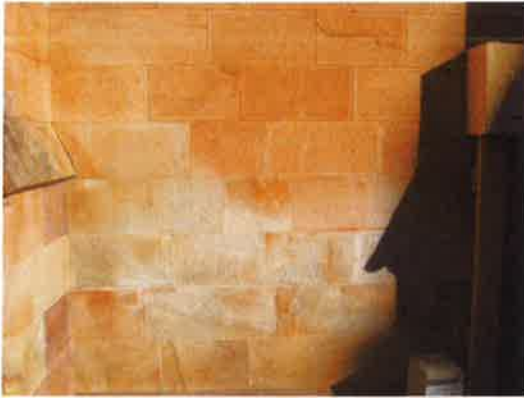
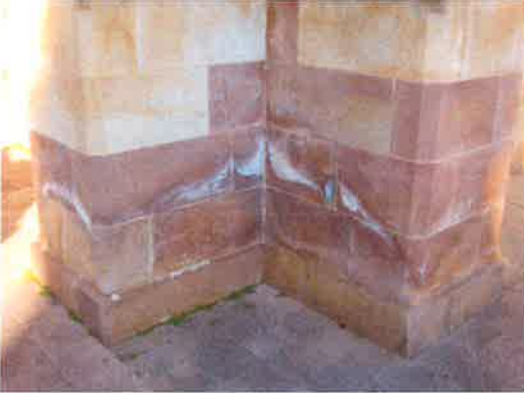
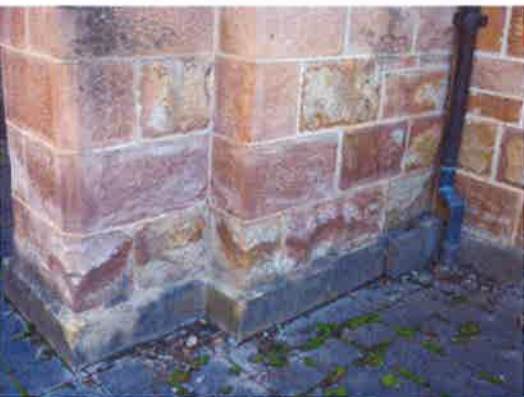
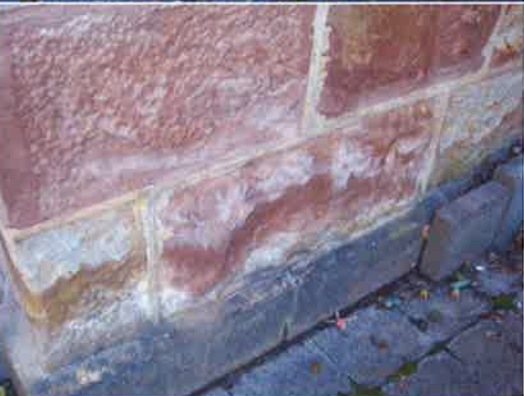
Photos 15-18 : Salt efflorescence at various locations around the building perimeter

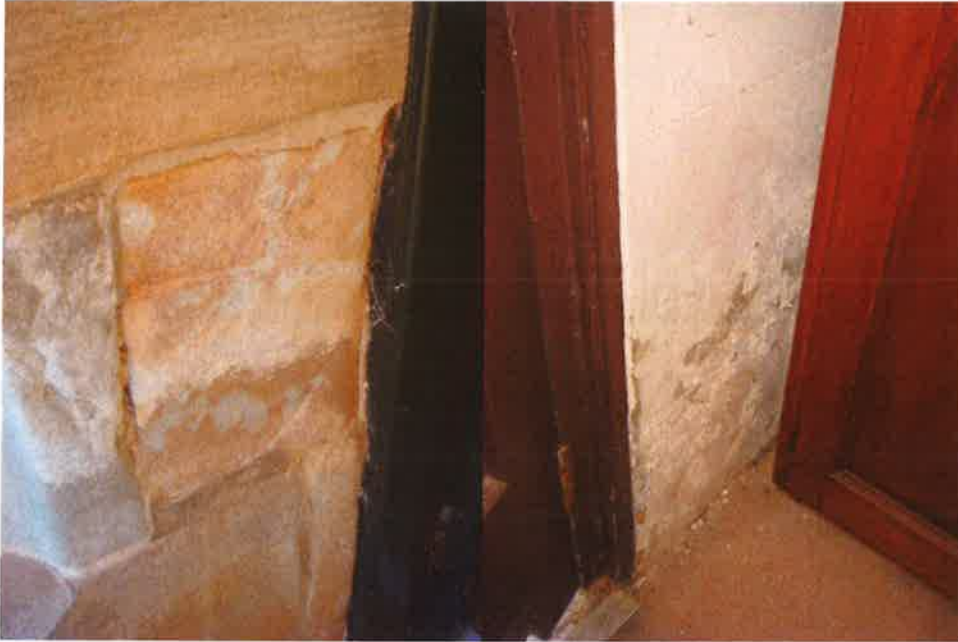
Photo 19: Salt attack and stone deterioration on the left side of the west porch doorway

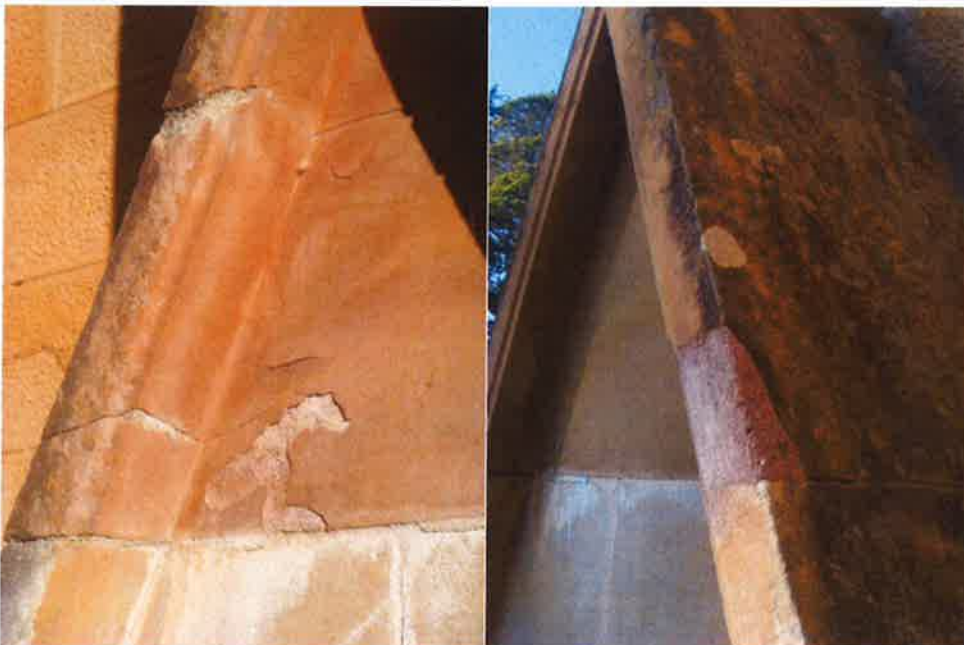
Photo 21: Typical stone deterioration at west side

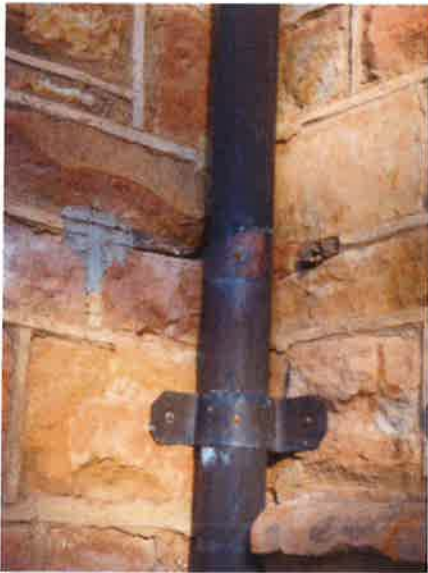
Photo 23: This downpipe bracket has been relocated inappropriately and the re-pointing has been poorly executed

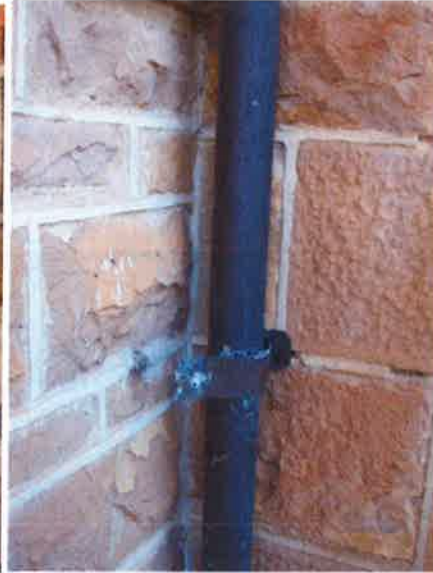
Photo 24: Loose downpipe bracket

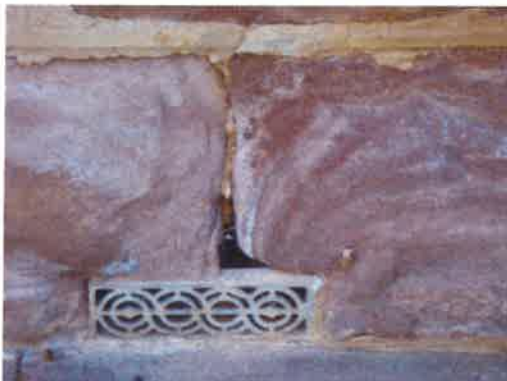
Photo 25: An example of highly eroded stone around a vent

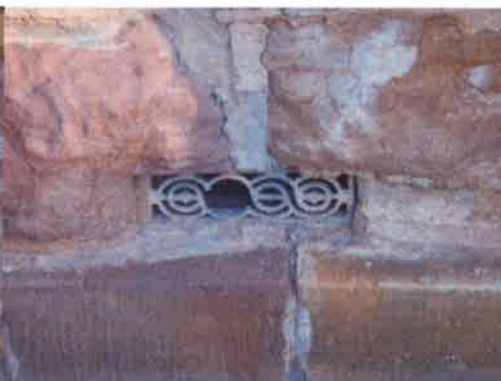
Photo 26: A broken cast iron sub-floor vent

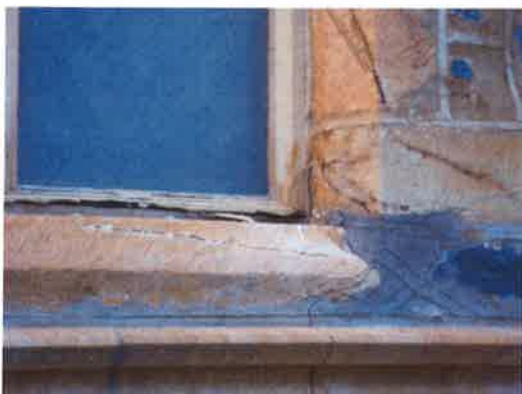
Photo 27: Failed apron flashing below window and poor re-pointing

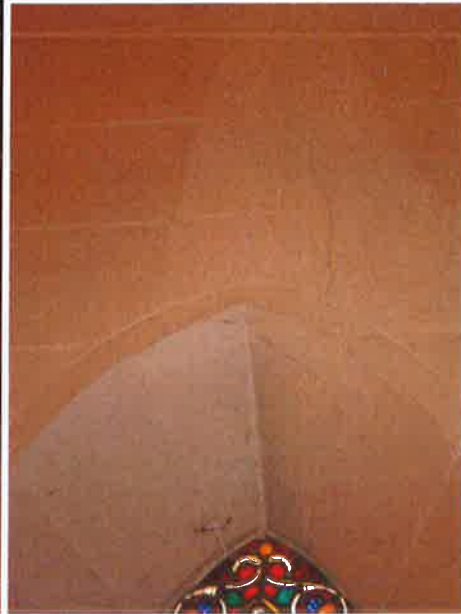
Photo 35: Typical movement cracks

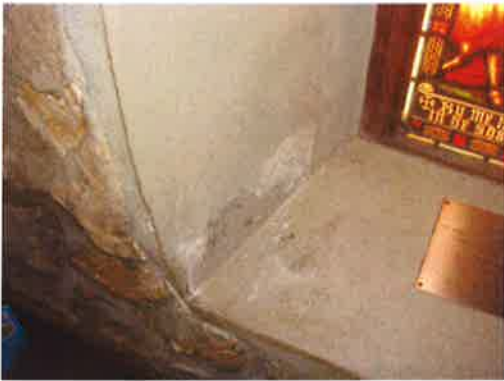
Photo 44: Moisture and salt attack at window sill in north porch

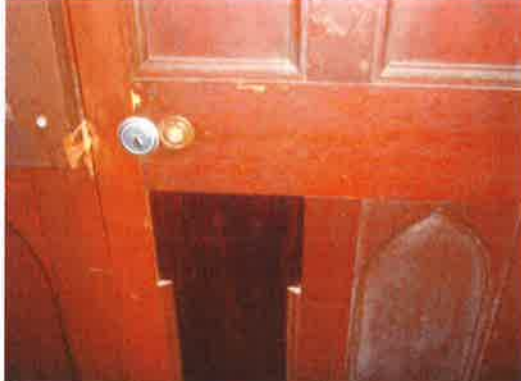
Photo 45: Damaged door under stairs in west porch

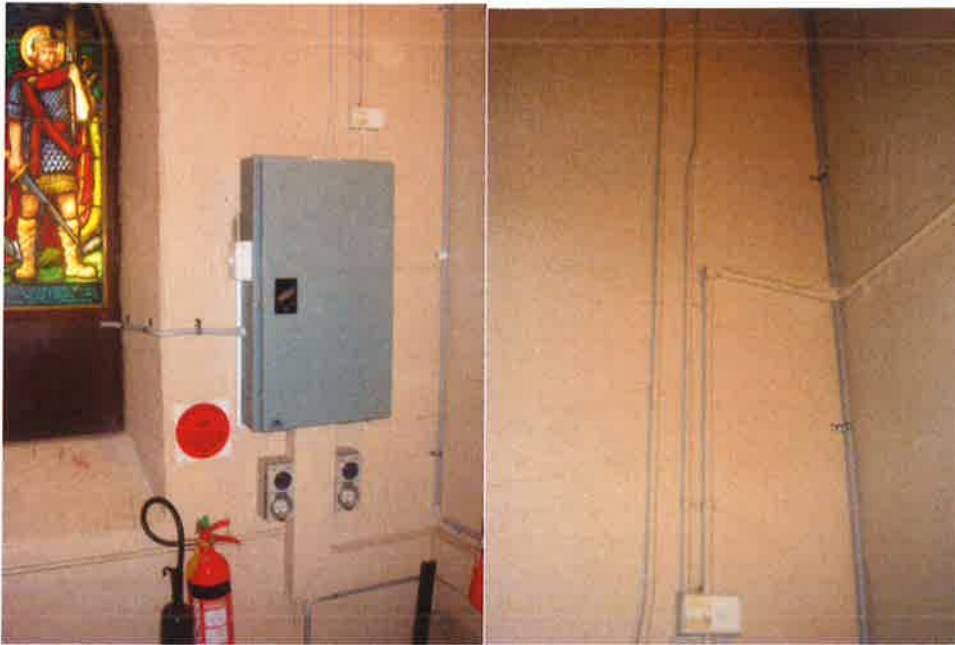
Photos 50 & 51: Showing the range of disparate and intrusive services

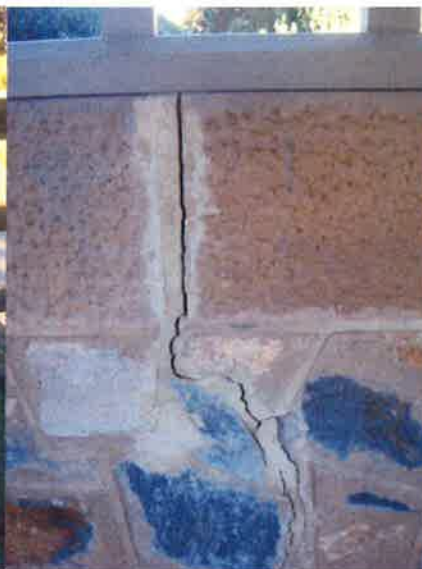
Photo 63: Evidence of past crack repair

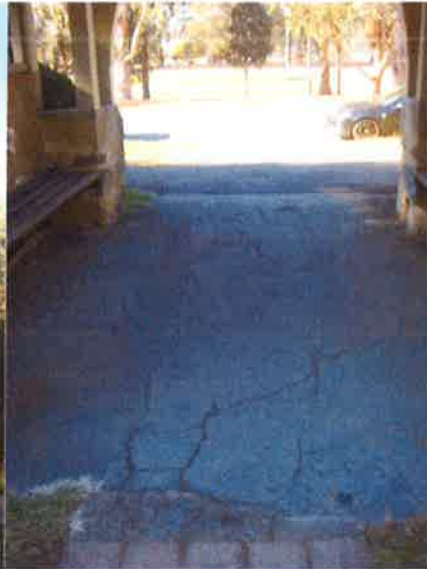
Photo 65: Cracked bitumen pavement

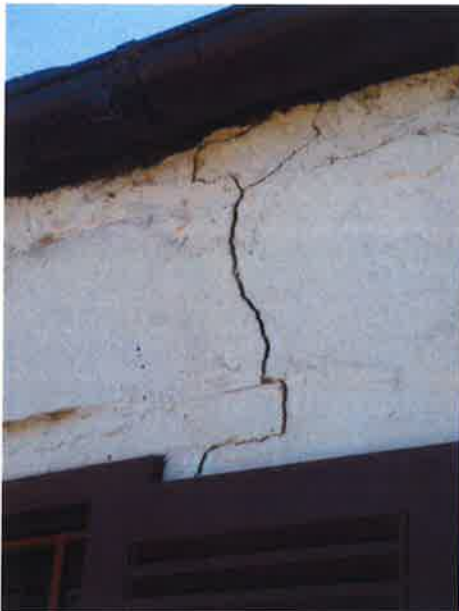
Photo 76: Moderate crack above south window

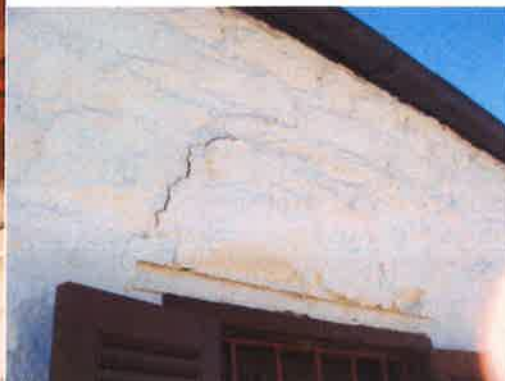
Photo 81: Minor crack above west side window

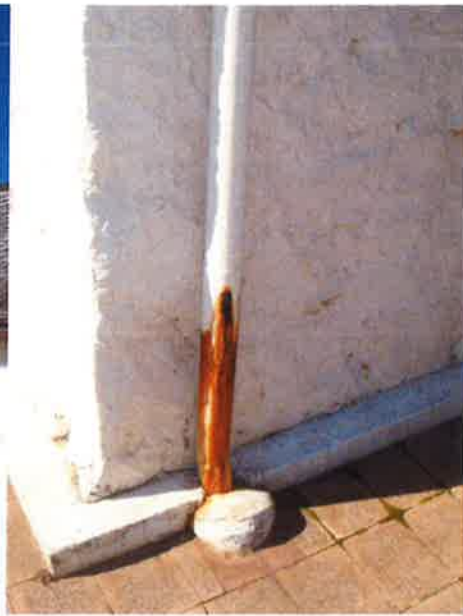
Photo 85: Leaking downpipe west side

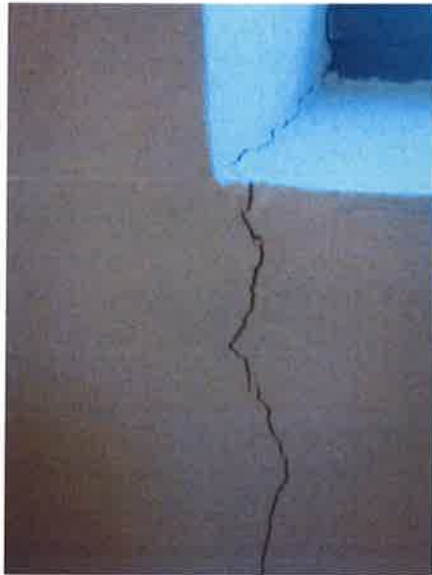
Photo 92: Room 4 cracking at window sill

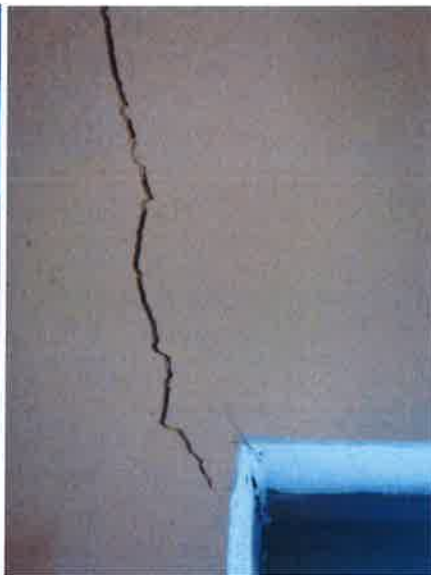
Photo 93: Room 4 cracking at window head

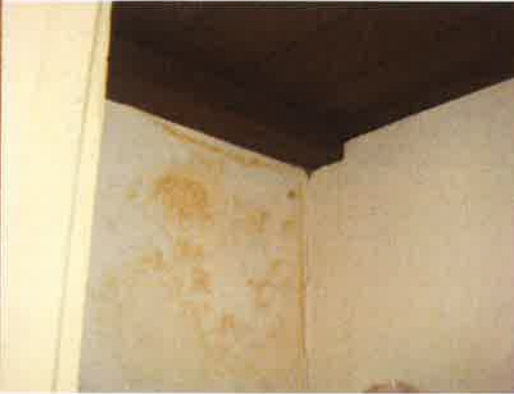
Photo 126: Water damage in Bed 3 closet

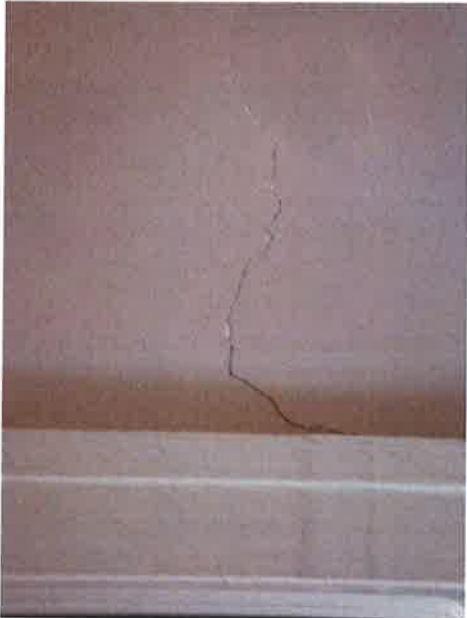
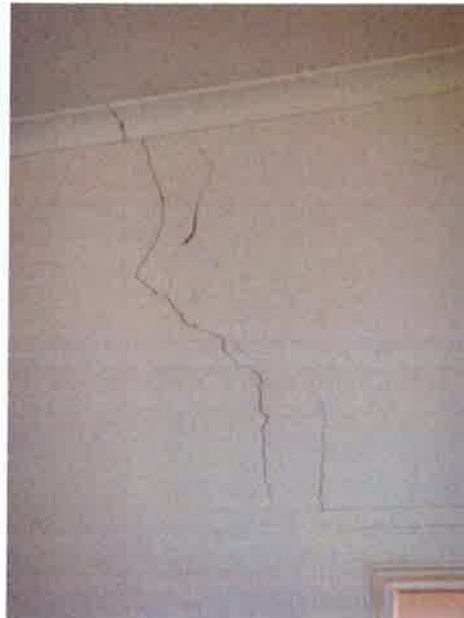
Photos 127 & 128: Typical cracking on internal walls
