## CONSERVATION MANAGEMENT PLAN

## ANGLICAN CHURCH OF ST JOHN THE BAPTIST CANBERRA, ACT - SIGNIFICANT STRUCTURES

Prepared by Philip Leeson Architects Pty. Ltd.

Issue: Final - Approved by ACT Heritage Council 10.11.15.

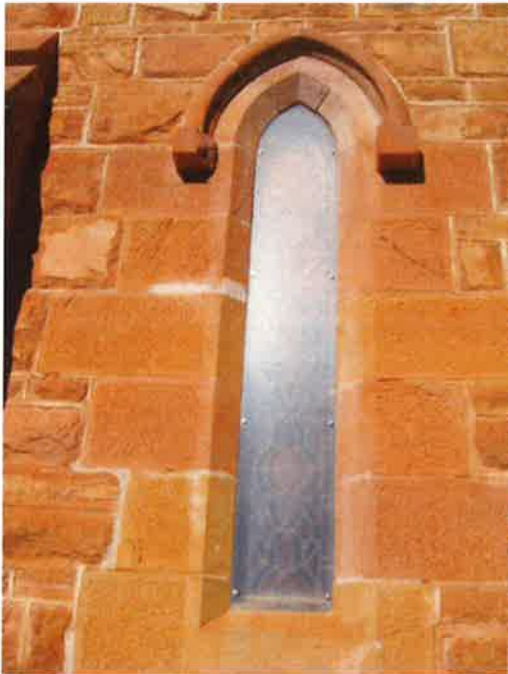
Photo 9: Typical lancet window showing cloudy protective polycarbonate cover

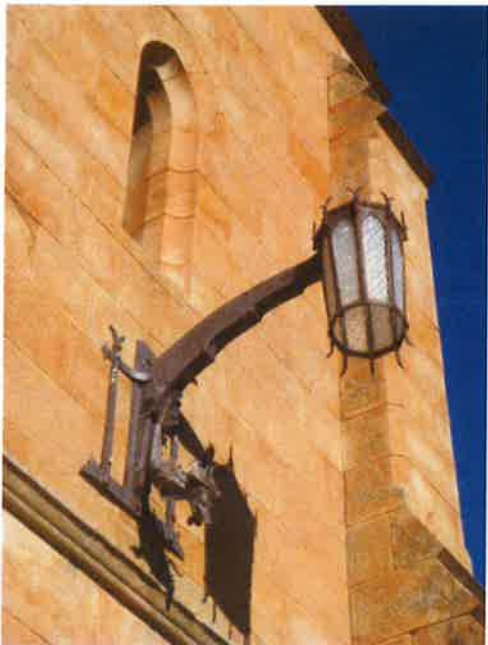
Photo 13: Dolpin lantern over West Entry, 1956 Photo 14: Stone deterioration at West Porch

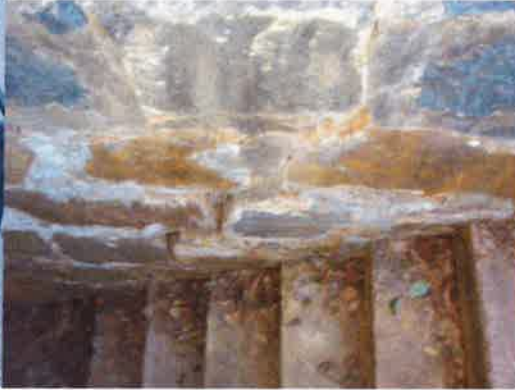
Photo 29: Movement in stone retaining wall

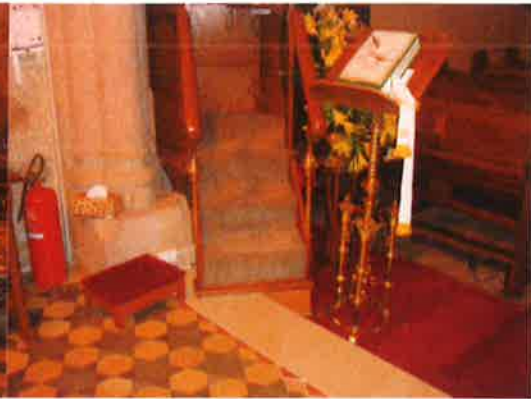
Photo 38: Pulpit and recently replaced stone step tread below Chancel arch.

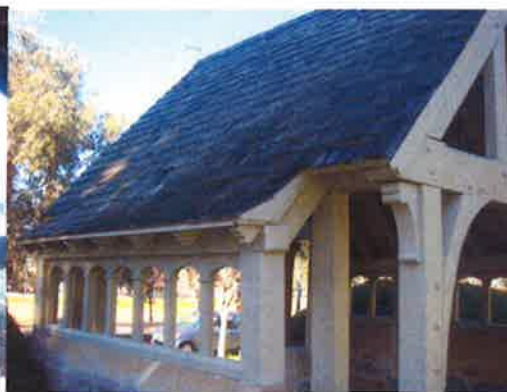
- the gates have sagged on their supports and require repair
- foundation settlement has caused minor movement in the stone walls
- the bitumen paving is cracked and requires replacement
- the shingles are weathered and are due for replacement

Photo 61: Roof detail showing weathered shingles

Timbers	Check timber elements annually for rot, termite or borer attack. Repair as required	Generally	Routine
Roof	Replace timber shingles with a suitable species as funding permits.	Both Roofs	Overdue
	Check shingle roofs annually for structural soundness, ensure waterproof and vermin proof Repair as required.	Both structures	Routine

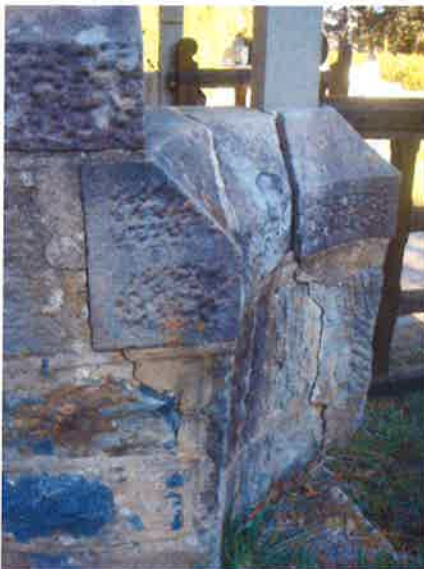
Photo 62: Stone movement

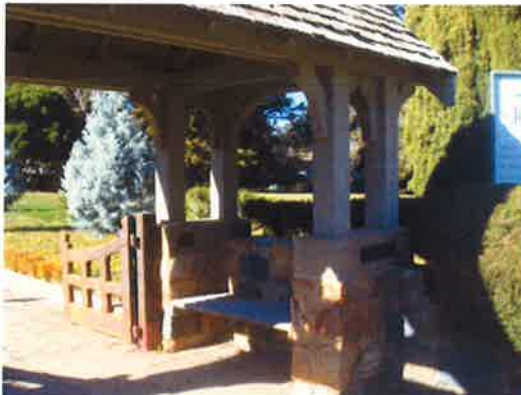
- the gates have sagged on their supports and require repair
- the shingles are highly weathered, particularly on the western slope and are due for replacement

Photo 71: Timber gates

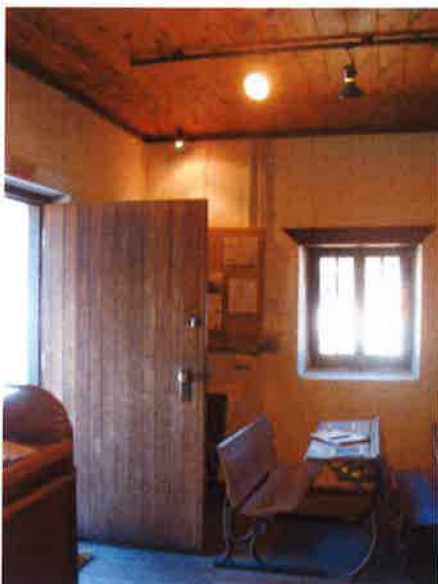
- numerous examples of cracking caused by foundation movements. This appears to be less than has occurred in the past
- the current cracking is dispersed reasonably evenly around the building and is predominantly on the inside of walls. The cracking is generally minor except for one crack above the south facing window in Room 4 within the stabilised zone.
- leaking, rusted downpipe in northwest corner
- rising damp and peeling paint on face of fireplace Room 1 and also Rooms 5 & 6.
- localised areas of drummy render
- spongy floor in Room 2
- split floorboard in Room 4.

Photo 89: Concrete ramp in Room 2

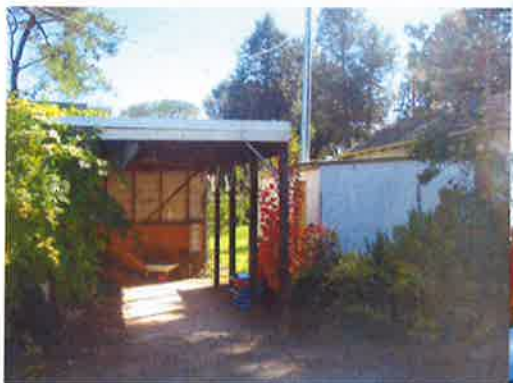
Photo 107: Carport and shed

- The carport and shed are in a fair condition but are of basic quality construction and are considered unsympathetic to the quality of the Rectory design.

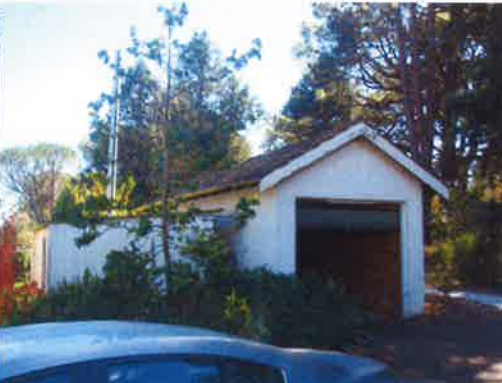
Photo 108: Garage

- The Garage in very poor condition with settlement cracking to masonry walls, rusted gutters, rotten woodwork and general neglect. A new roller door was installed in August 2014 to make the garage useable pending replacement.

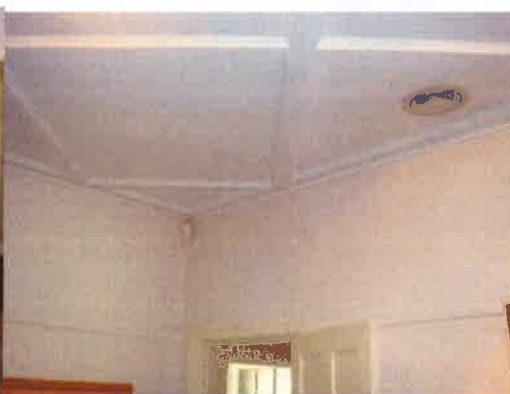
Photo 114: Dining room ceiling

- The ceiling is sagging in several locations
- Damaged boards in subfloor access door, south side
- The concrete terrace and pergola is of inferior design and quality to the original building and could be improved

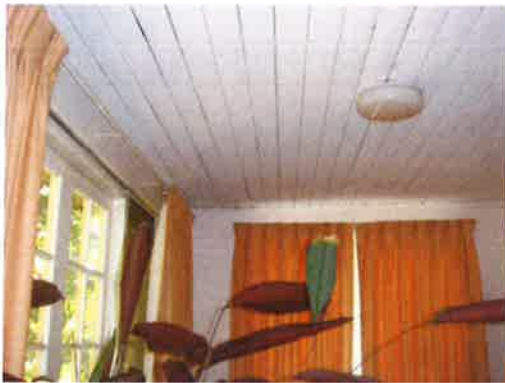
Photo 115: Enclosed verandah off Dining room

- Dirt and debris falling through ceiling boards in South Verandah (off Dining Room)
- Several instances of split, cracked and warped roof timbers and previous inexpert repairs

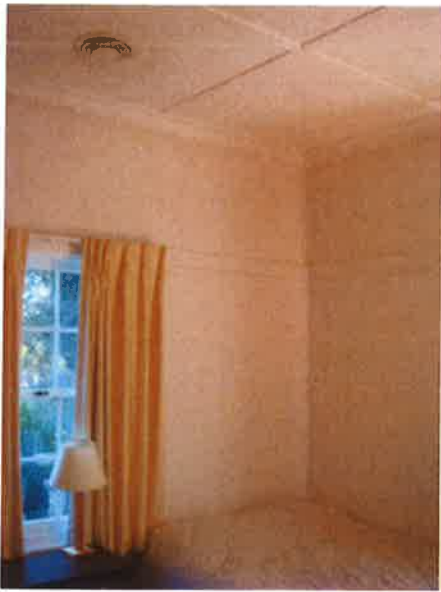
Photo 125: Bedroom 3

- Water damaged wall inside bedroom 3 closet caused by leaking ensuite shower
- The main ridgeline near main chimney has sagged, probably due to inadequate propping below. However the ridge tiles have been parged up in this position and are currently secure.
